1. AGENCY USE ONLY (Leave blank)	2. REPORT DATE 1996	3. REPORT TYPE AND DATES COVERED Final Report		
4. TITLE AND SUBTITLE The Old Hospital Complex (5EP1778) Fort Carson, Colorado		5. FUNDING NUMBERS

13. ABSTRACT (Maximum 200 words) <p>The Old Hospital Complex (5EP1778) at Fort Carson, Colorado, consists of 59 buildings. The Complex was built during World War II and is significant due to its association with the history of the United States. The complex is semi-permanent construction, constructed from the Department of the Army's Series 800 plans. This report documents the complex in accordance with Section 1(g) of the Memorandum of Agreement enacted among the Department of the Army, Headquarters Fort Carson, the Colorado State Historic Preservation Office, and the Advisory Council on Historic Preservation.</p> <p style="text-align: center;">DTIC QUALITY INSPECTED 2</p>

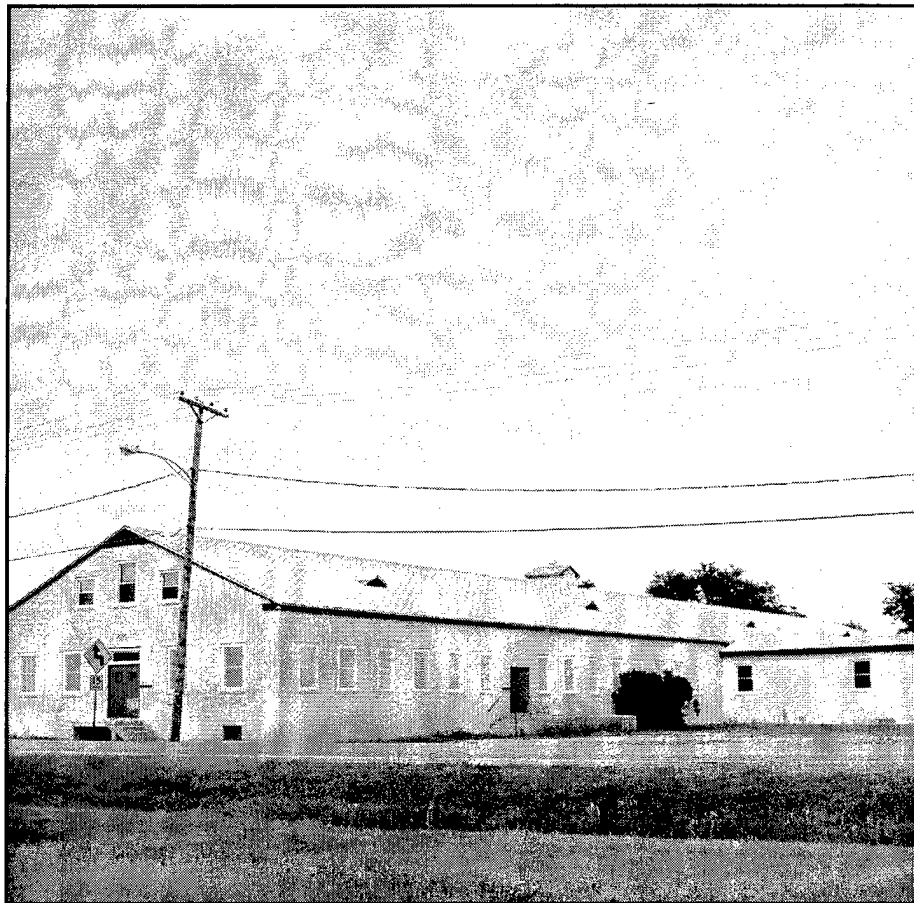
Figure V.262 5EP1778. Building S6271, Storehouse, 800 Series, Type HST-2. Three-quarter view of west wing's west and south faces. Also includes west face of north side of corridor connecting to Buildings S6273 and S6274. Roll 15F, Exposure 3.

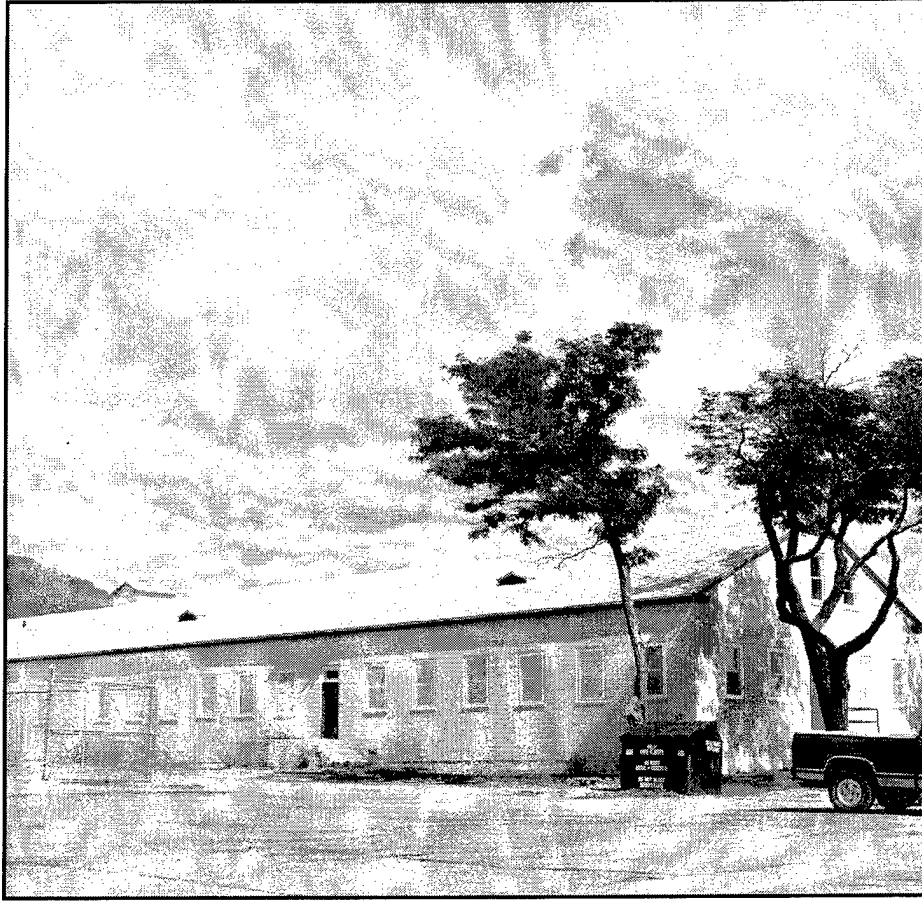
Figure V.263 5EP1778. Building S6271, Storehouse, 800 Series, Type HST-2. Three-quarter view of east side's east and south faces. Roll 8F, Exposure 5.

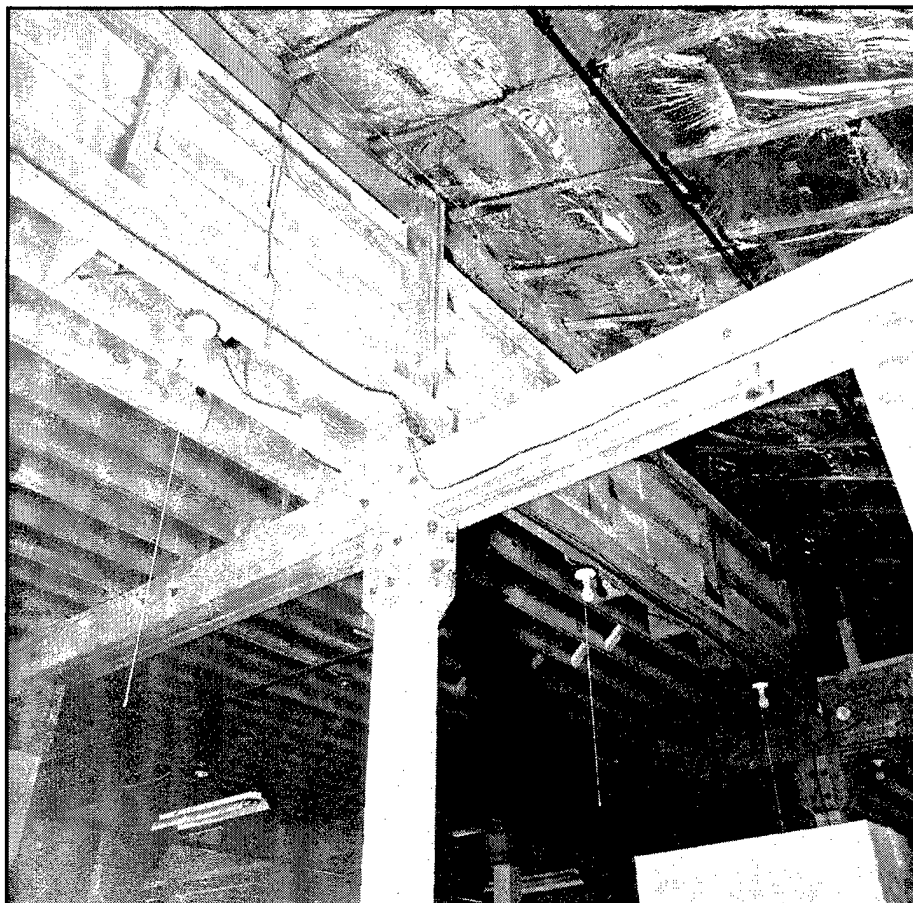
Figure V.264 5EP1778. Building S6271, Storehouse, 800 Series, Type HST-2. Interior shot, attic space, of an open area to the attic. Roll 2F, Exposure 5.

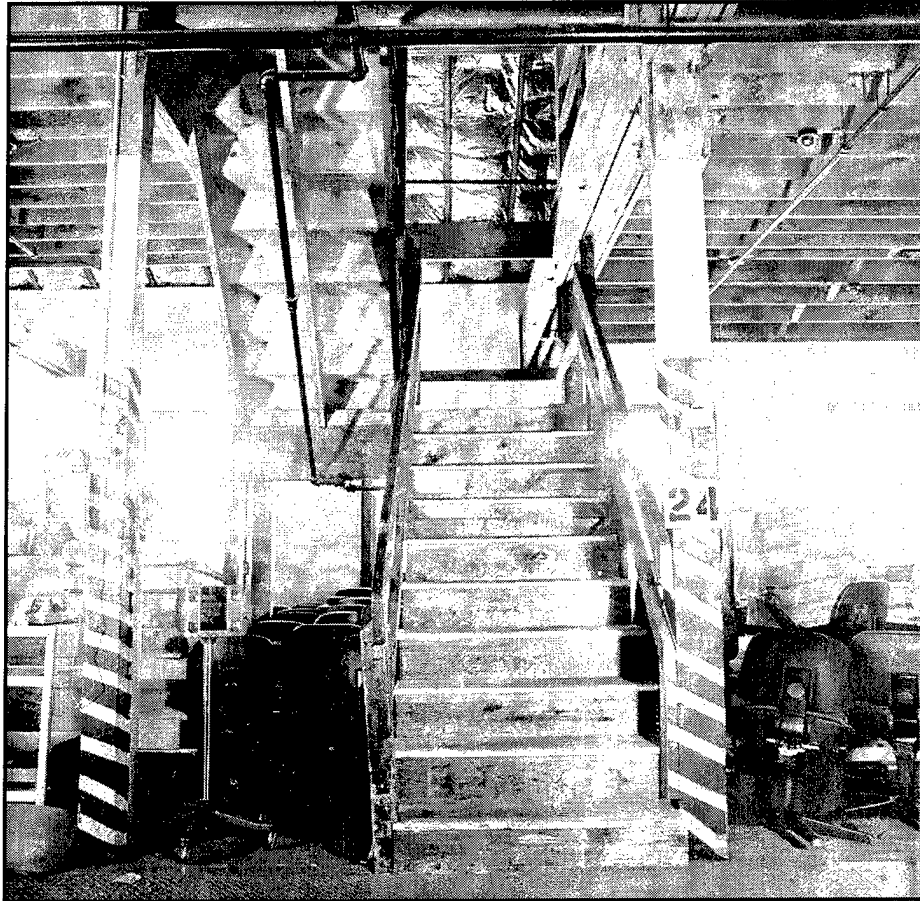
Figure V.265 5EP1778. Building S6271, Storehouse, 800 Series, Type HST-2. Interior shot of wood staircase. Roll 2F, Exposure 3.

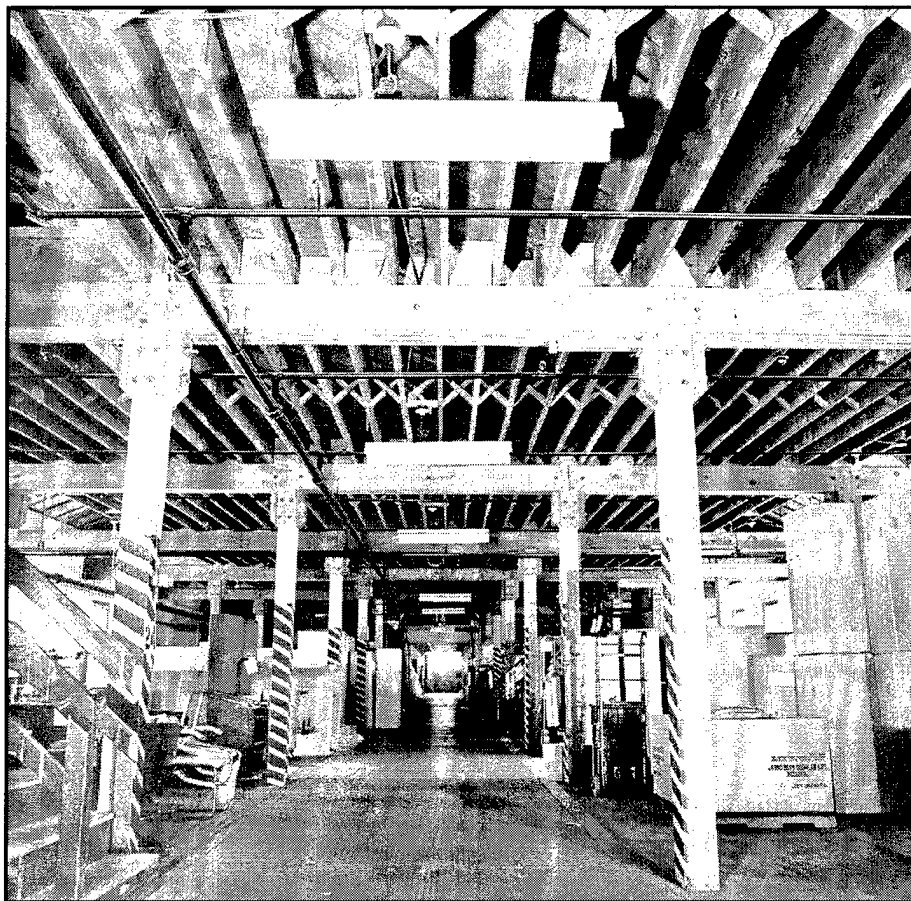
Figure V.266 5EP1778. Building S6271, Storehouse, 800 Series, Type HST-2. Interior shot of lower level with wood rafter ceiling, viewed from west end, looking east. Roll 1F, Exposure 10.

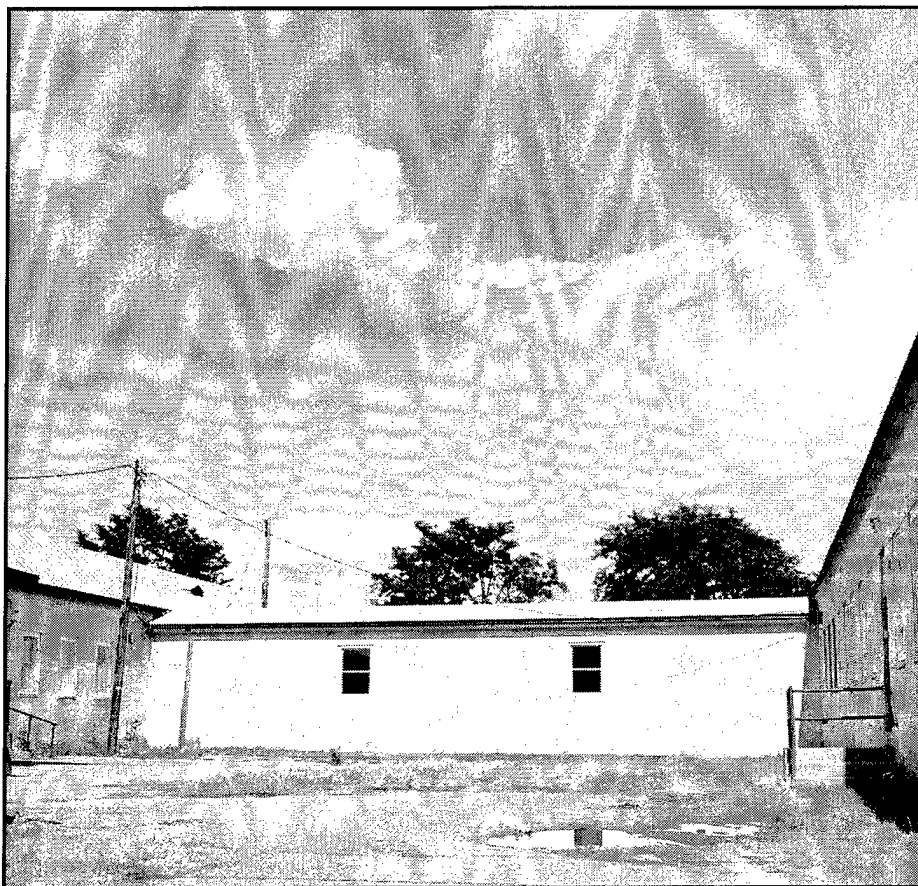
Figure V.267 5EP1778. West face of corridor connecting Buildings S6271 and S6270. 800 Series, Type H.C.WK.-A. Roll 15F, Exposure 11.

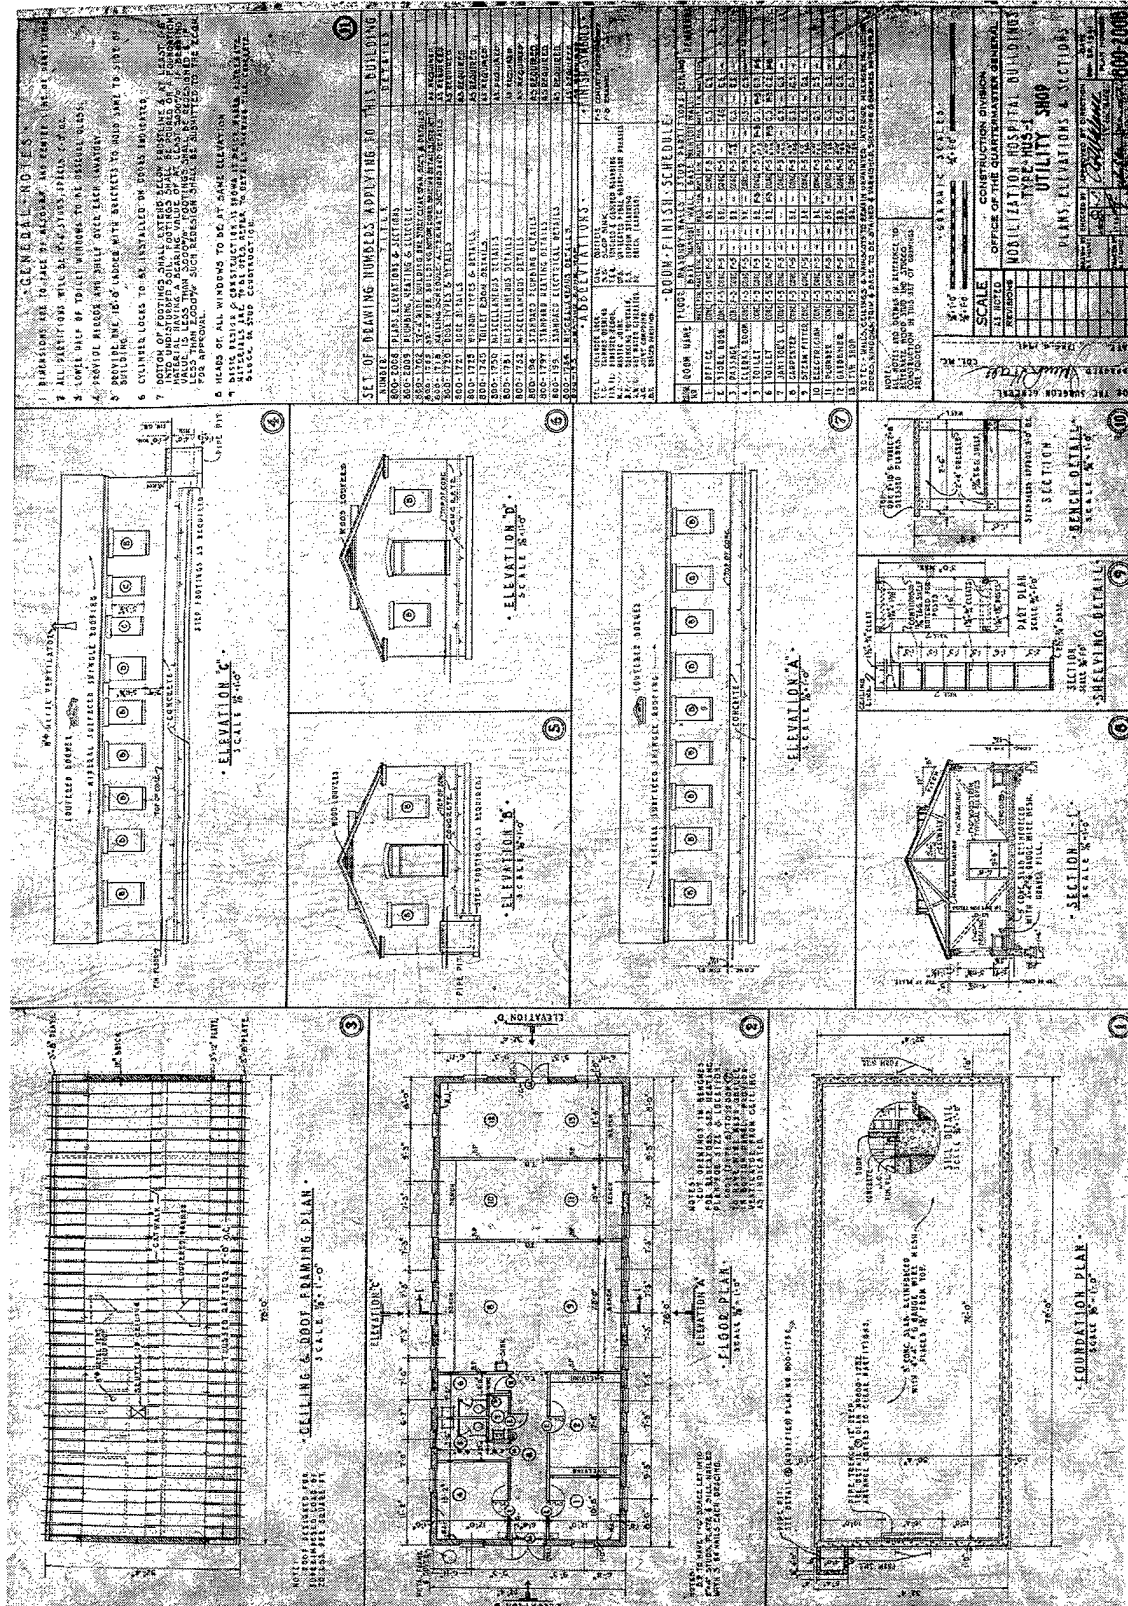
Figure V.268 5EP1778. Plans, elevations, and sections for Building S6276, Utility Shop, 800 Series, Type HUS-1, Plan 800-2008.

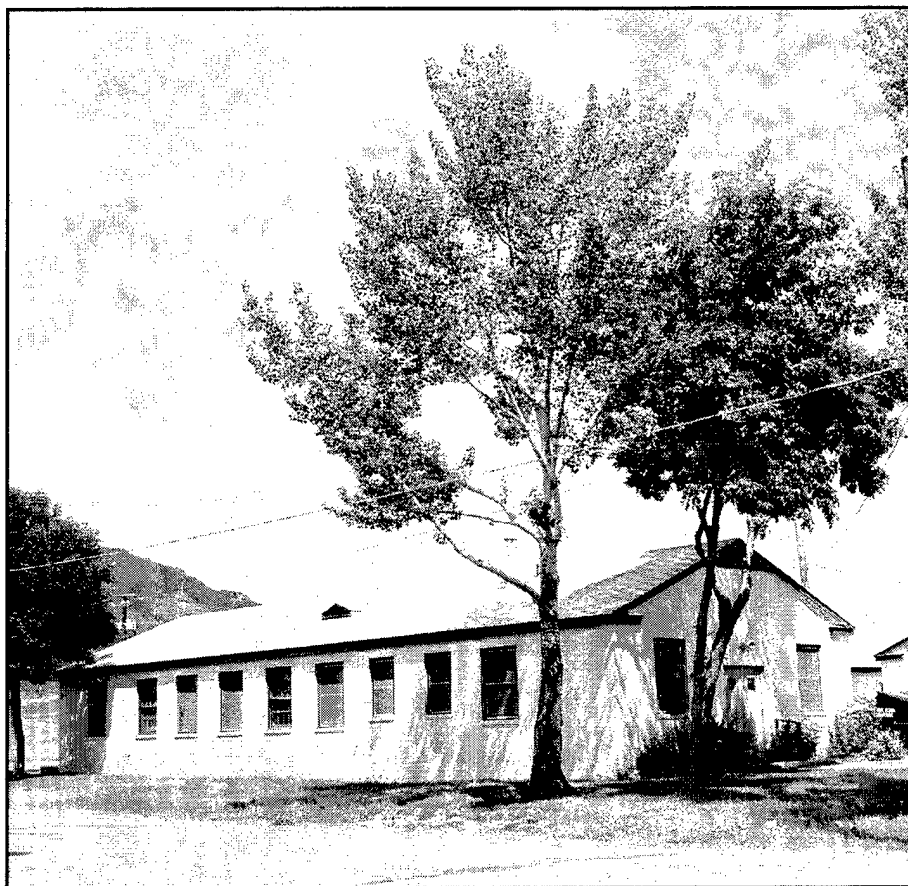
Figure V.269 5EP1778. Building S6276, Utility Shop, 800 Series, Type HUS-1. Three-quarter view of east and south faces. Roll 11F, Exposure 4.

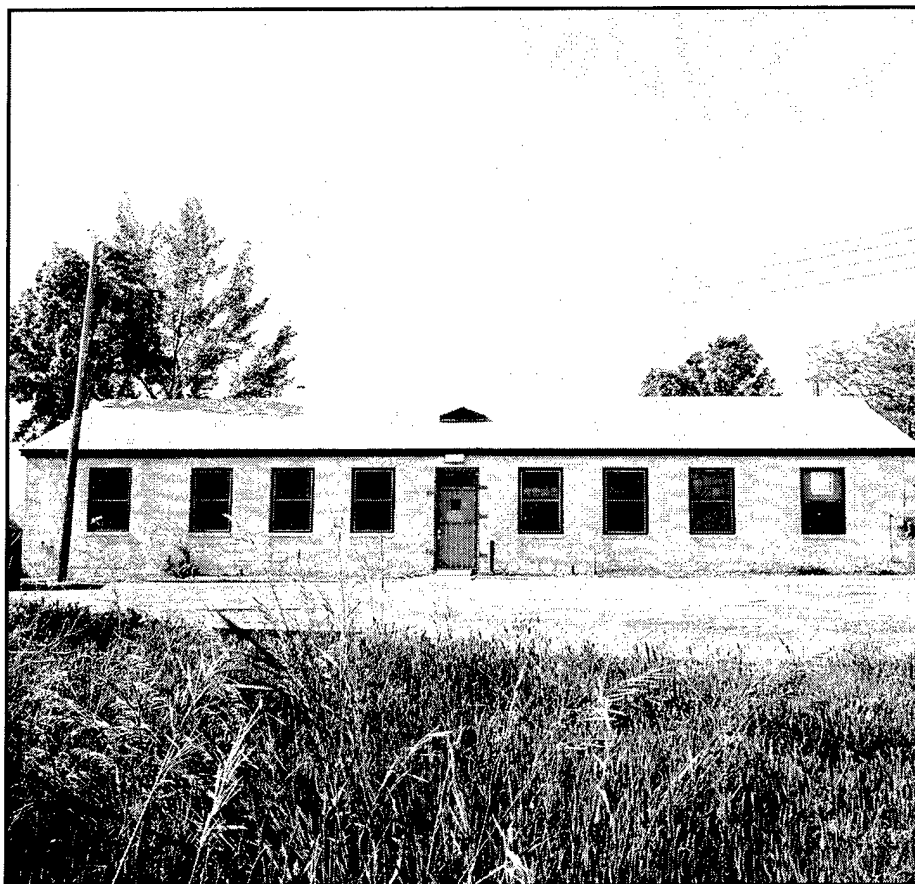
Figure V.270 5EP1778. Building S6276, Utility Shop, 800 Series, Type HUS-1.
North face. Roll 6F, Exposure 11.

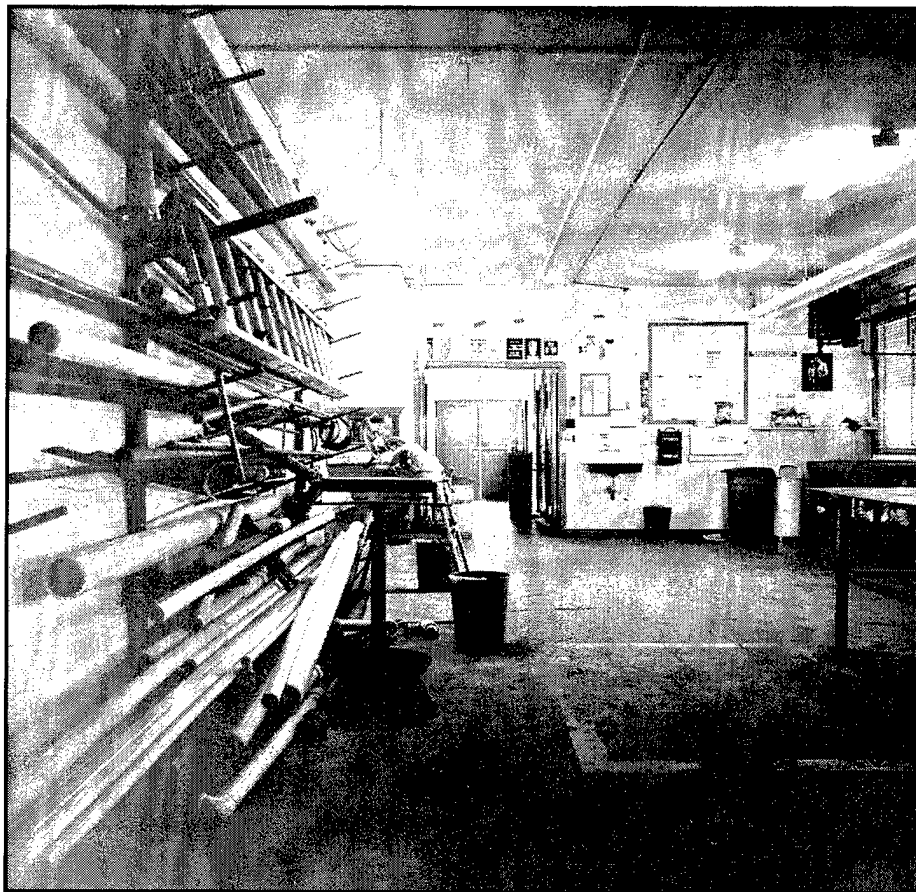
Figure V.271 5EP1778. Building S6276, Utility Shop, 800 Series, Type HUS-1. Interior shot from building's east side. Roll 6F, Exposure 2.

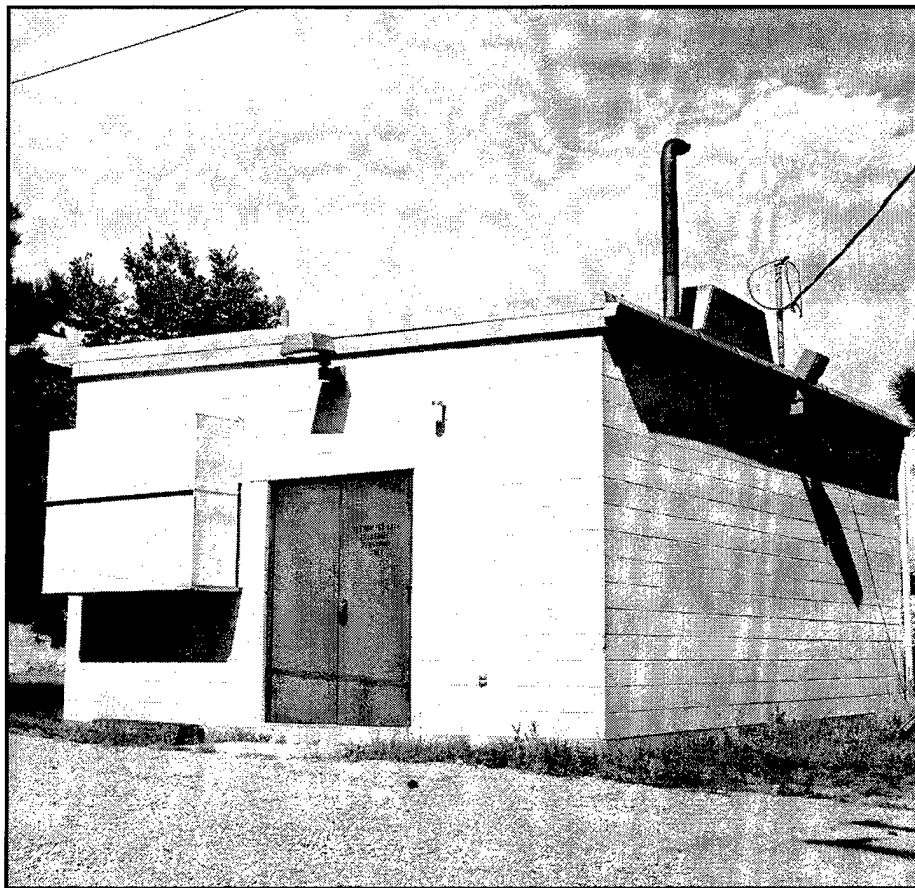
Figure V.274 5EP1778. Building P6229, Generator Plant. Three-quarter view of south and west faces. Roll 8I, Exposure 5.

The building exterior has been slightly modified. As designed for the U.S. Army Corps of Engineers, the building had just one entry. The building's original construction plans were modified to include a second, single entrance on the north wall. This is the only known modification to the building itself. A small fenced enclosure to the building's north and east side holds a cooling tower for the generator's engine. This enclosure is accessed from the building's north door.

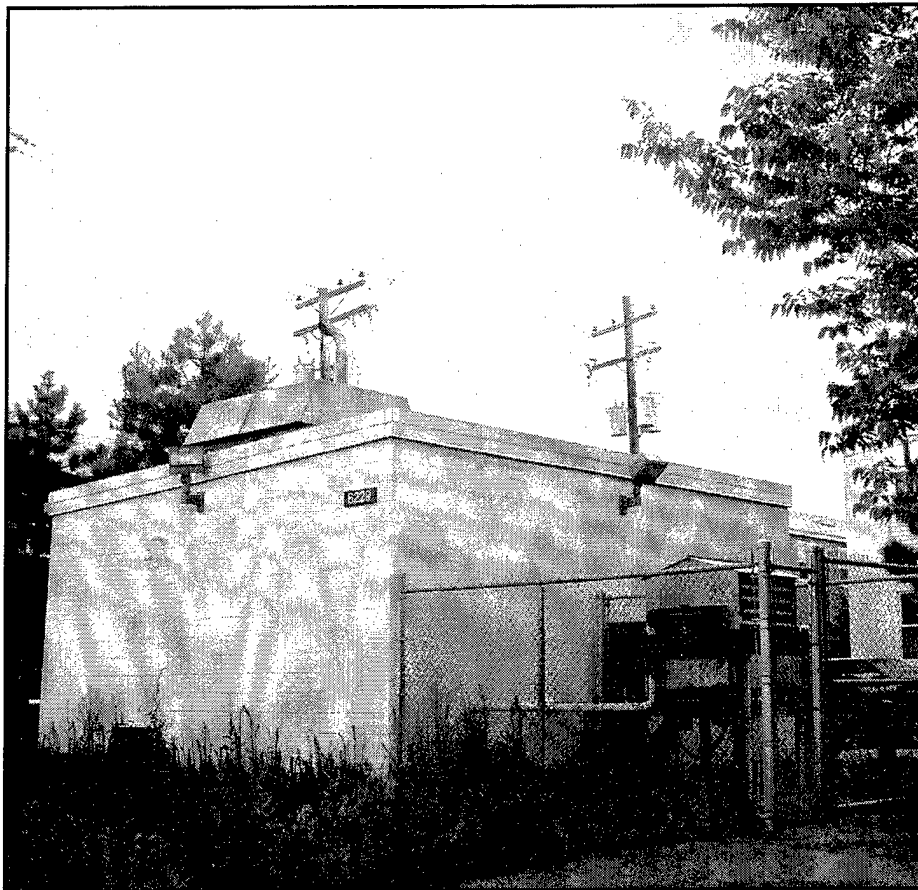
Figure V.275 5EP1778. Building P6229, Generator Plant. Three-quarter view of north and east faces. Roll 1A, Exposure 8.

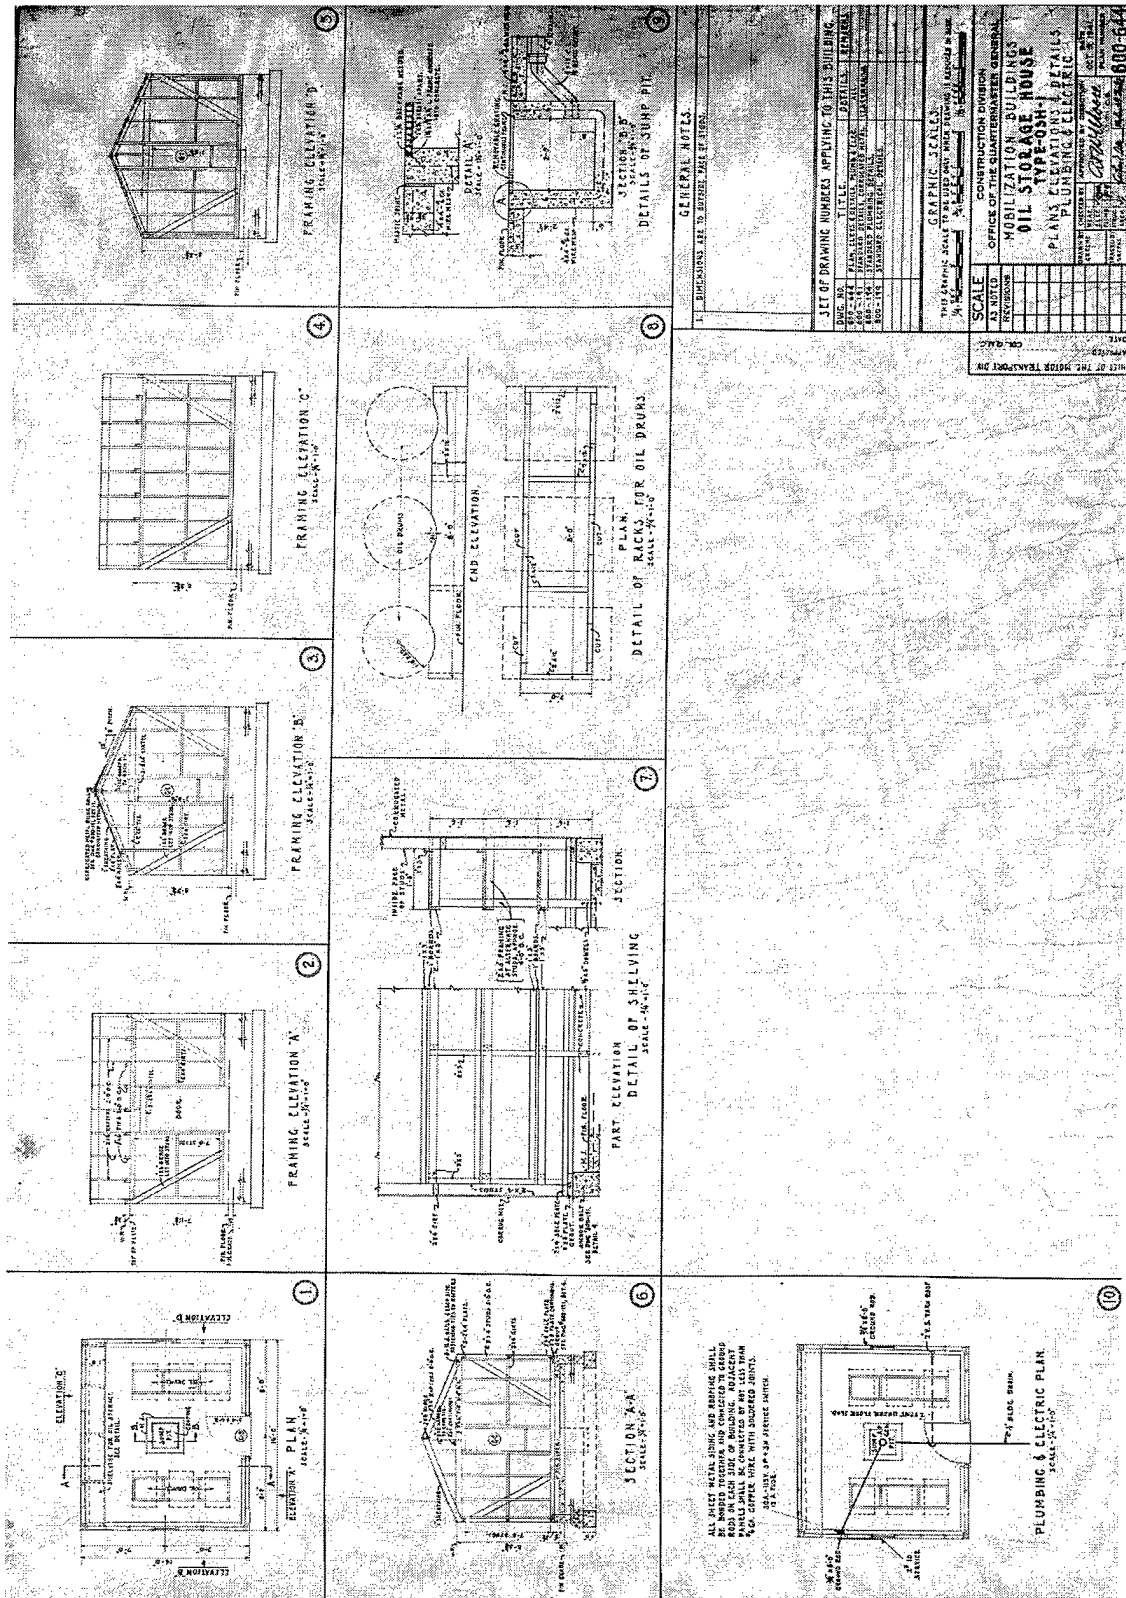
Figure V.276 5EP1778. Plans, elevations, and details for Building T6289, Oil Storage House, 800 Series, Type OSH-1. Plan 800-644.

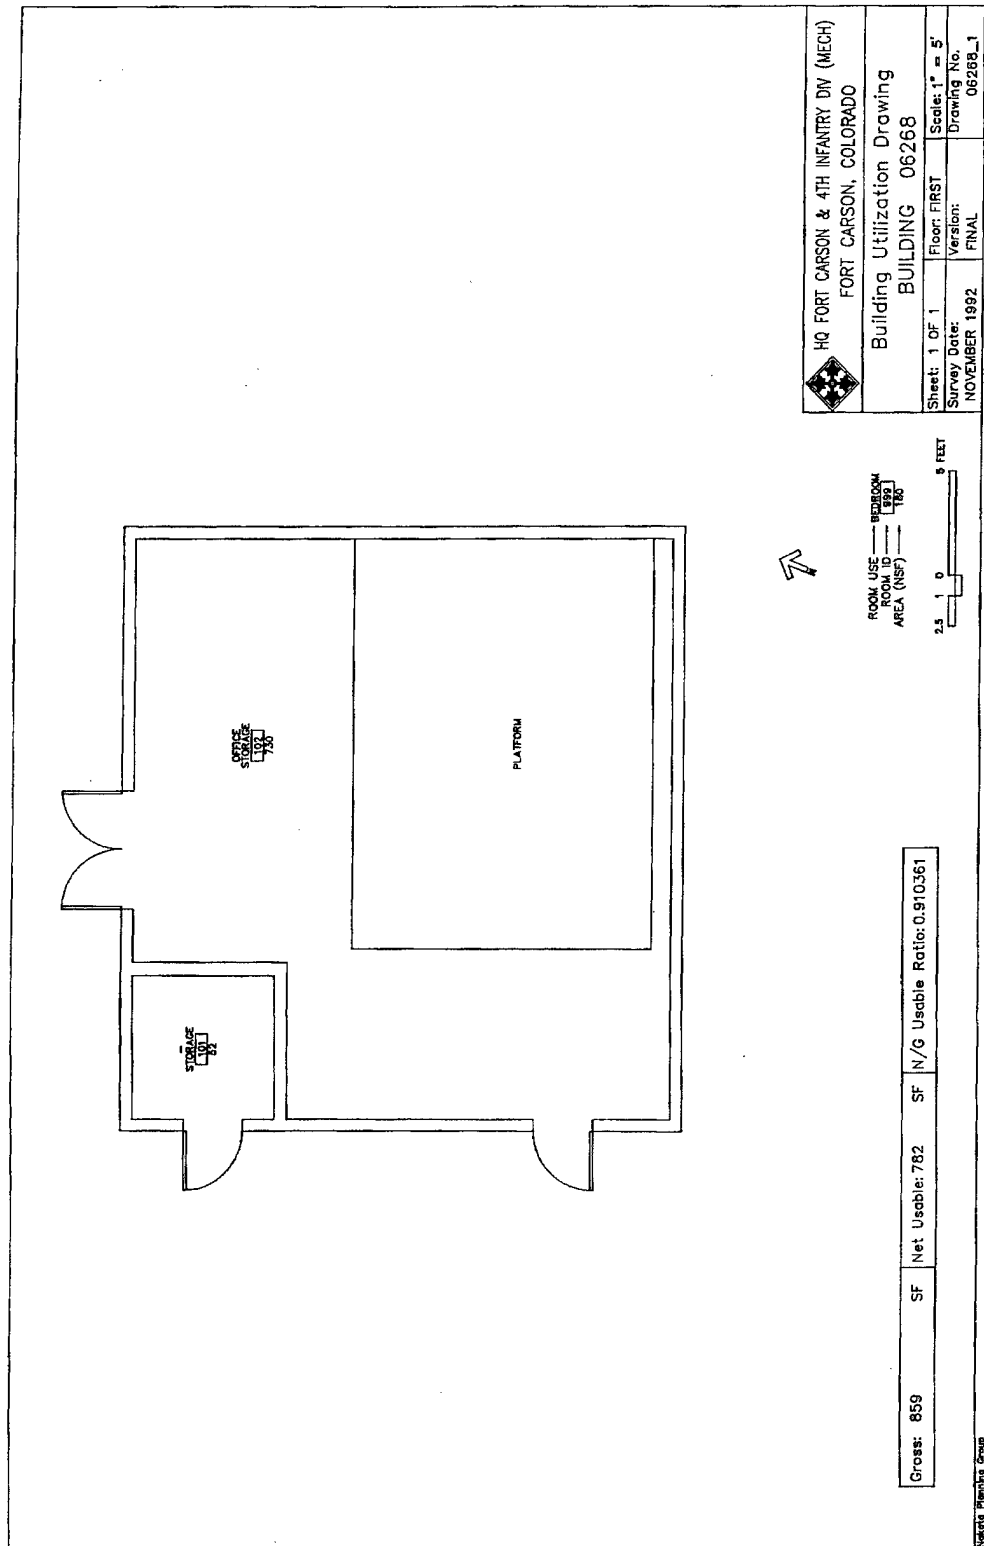
Figure V.277 5EP1778. Floor plan for Building P6268, Standby Generator Plant. BUD Series, dated 1992.

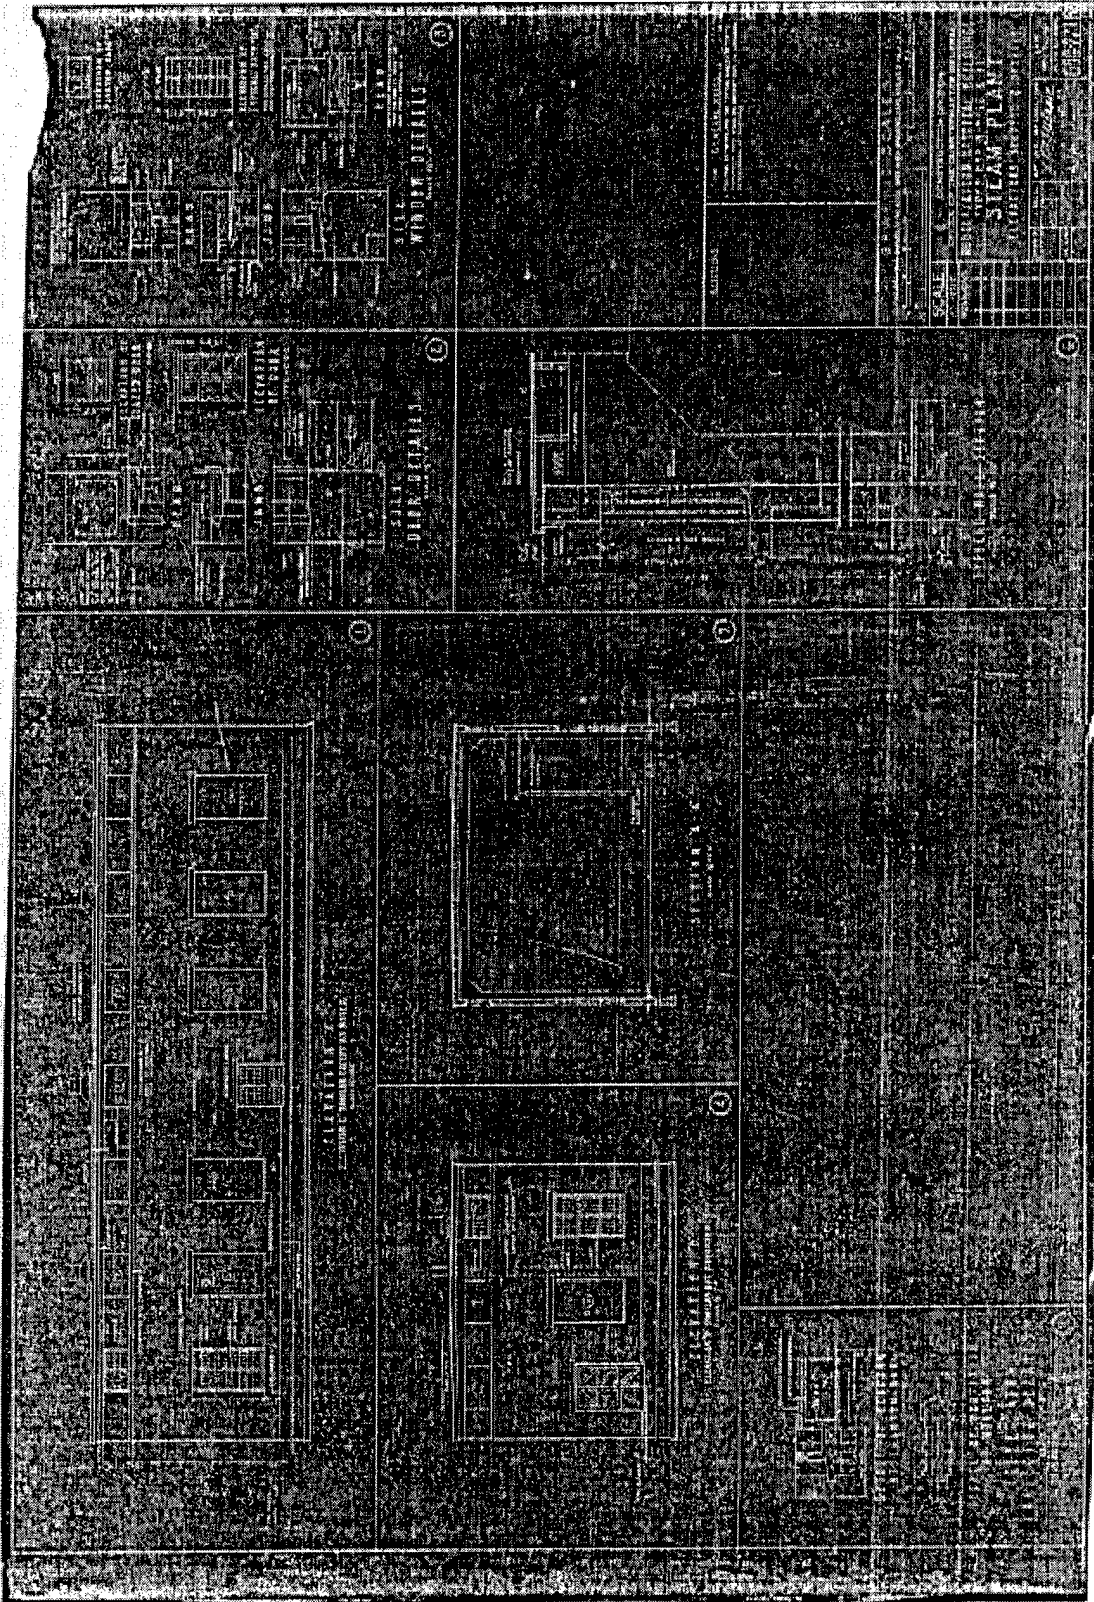
Figure V.278 5EP1778. Elevations, sections and details for Building S6290, Steam Plant, 800 Series, Type HSP-8, -9, -10, and -11, Plan 800-2216.

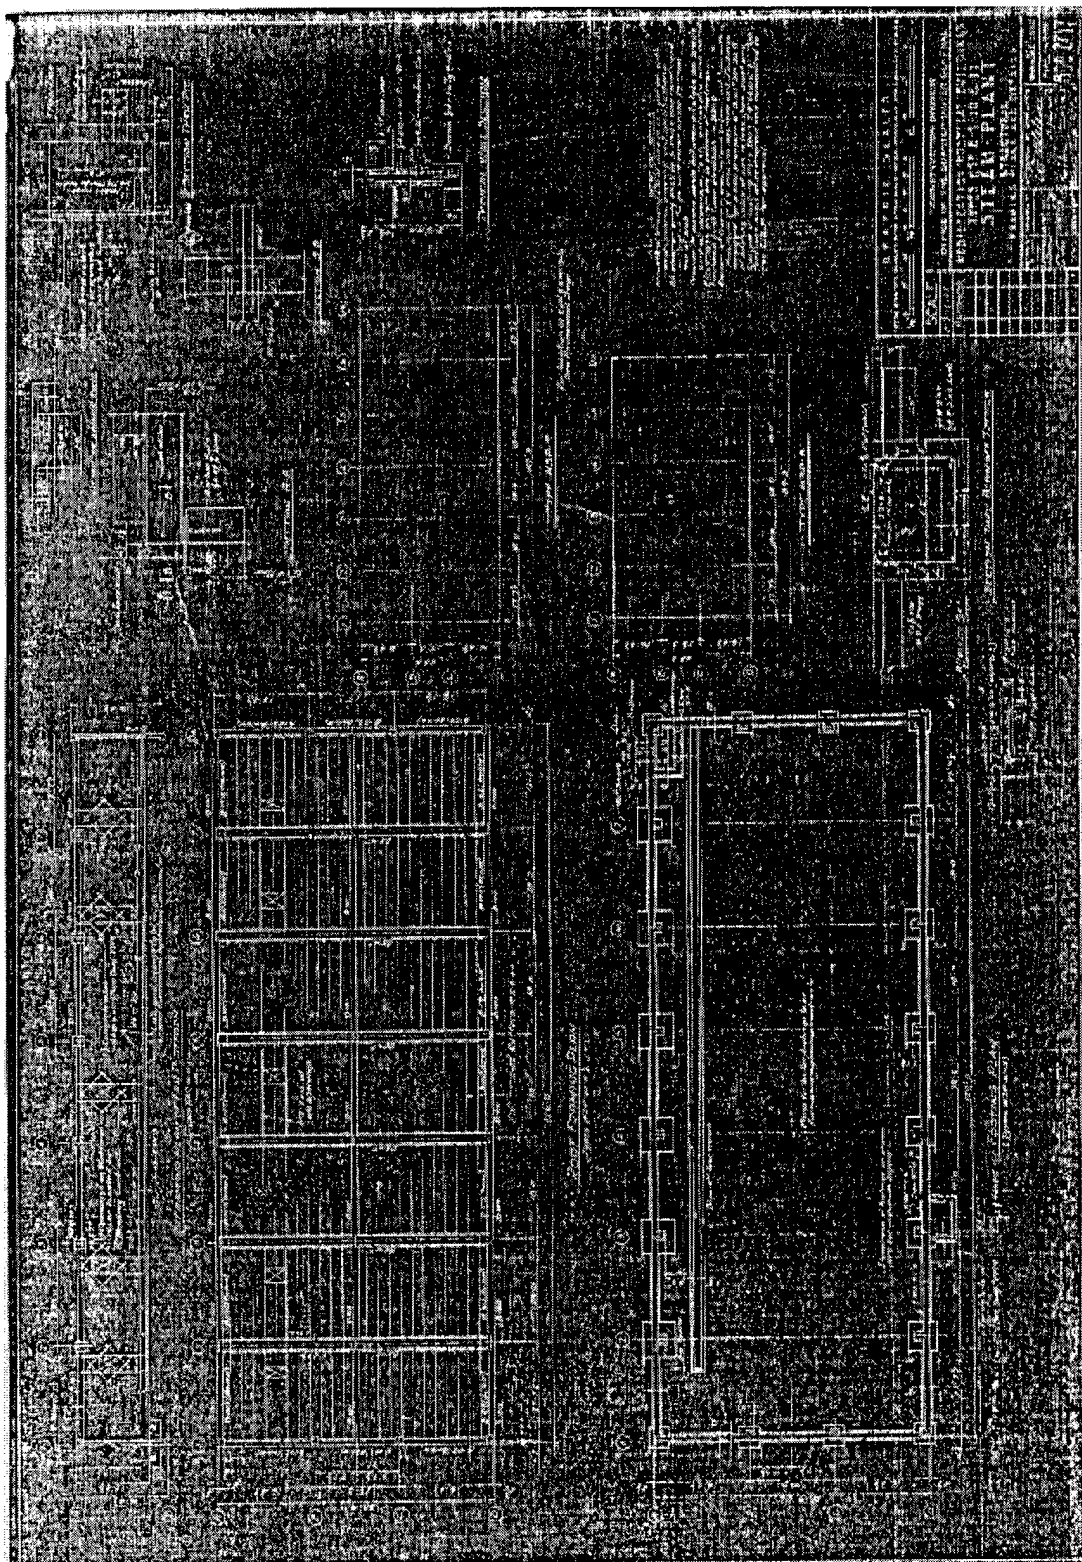
Figure V.279 5EP1778. Structural framing plans and details for Building S6290, Steam Plant, 800 Series, Type HSP-8, -9, -10, and -11, Plan 800-2217.

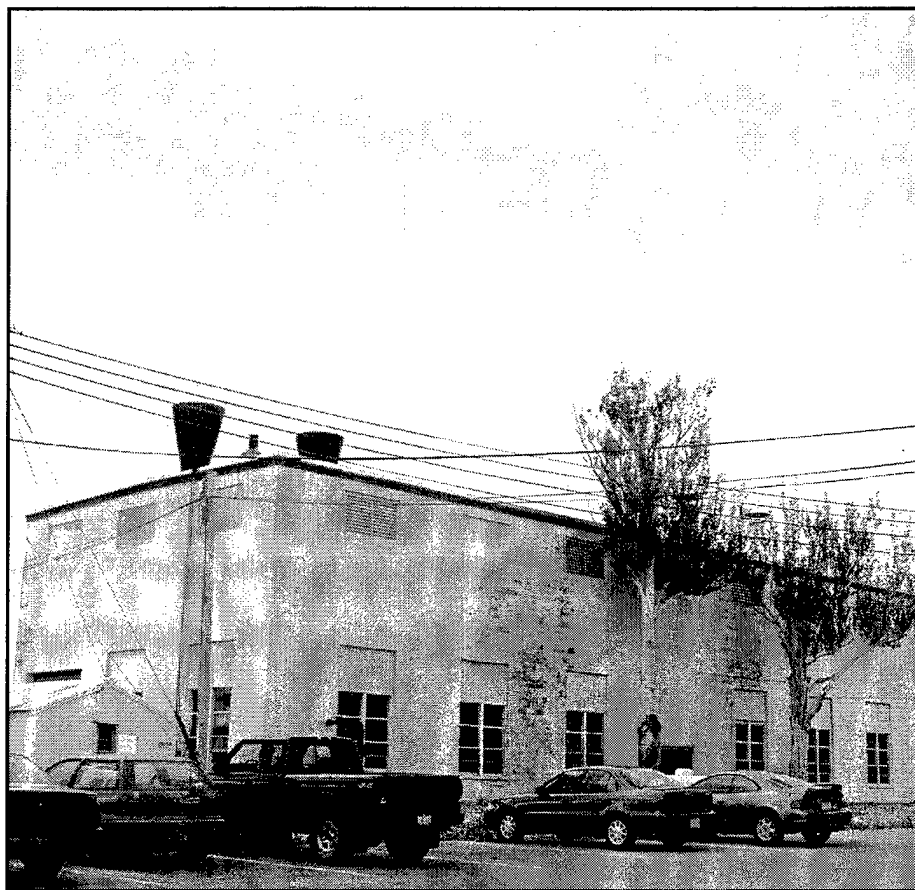
Figure V.281 5EP1778. Building S6290, Steam Plant, 800 Series, Types HSP-8, -9, -10, and -11. Three-quarter view of north and east faces. Roll 13F, Exposure 6.

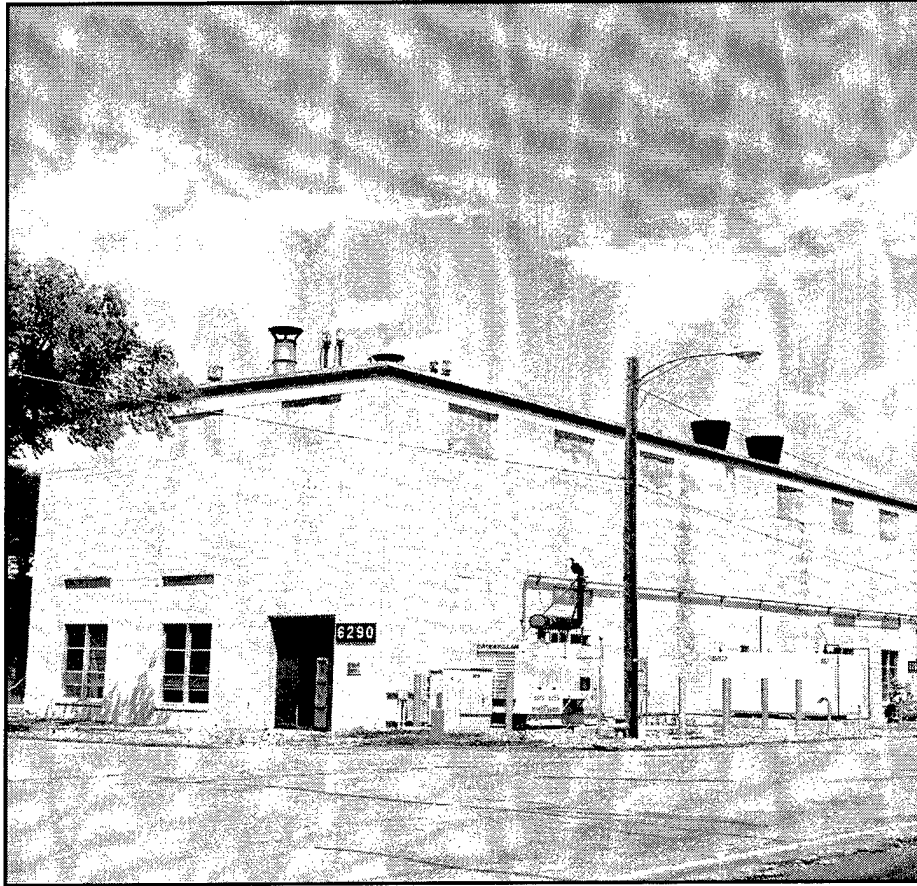
Figure V.282 5EP1778. Building S6290, Steam Plant, 800 Series, Types HSP-8, -9, -10, and -11. Three-quarter view of south and west faces. Roll 12F, Exposure 5.

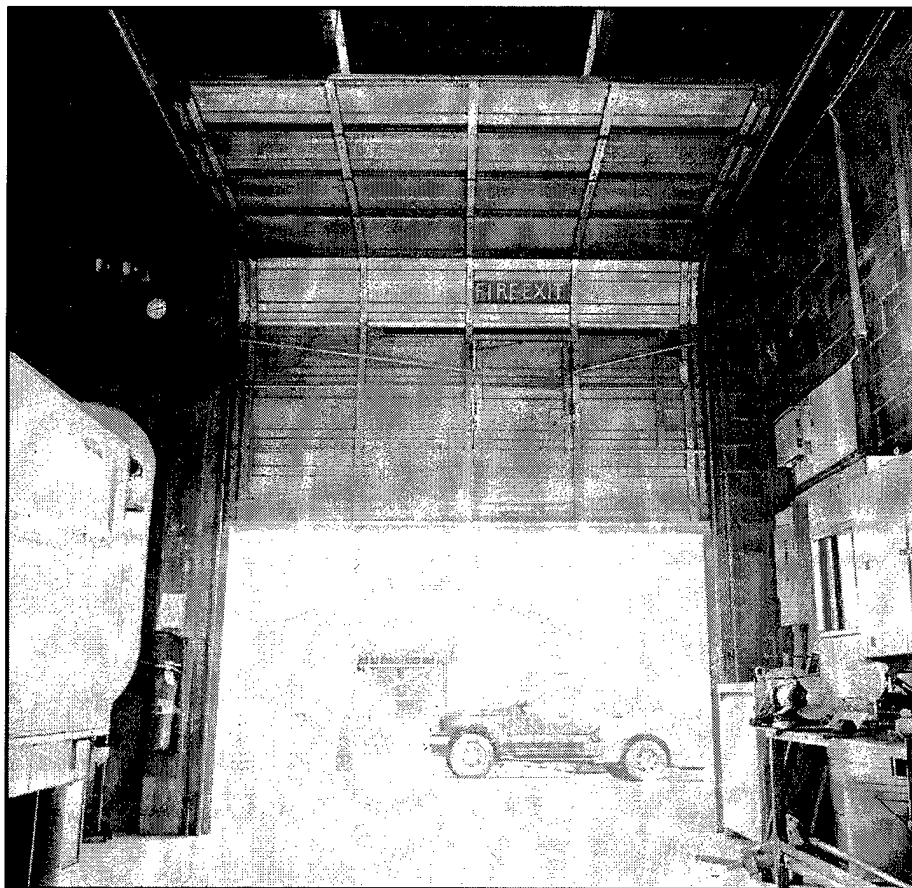
Figure V.283 5EP1778. Building S6290, Steam Plant, 800 Series, Types HSP-8, -9, -10, and -11. Interior shot, east side of garage door with small door inset. Roll 5F, Exposure 6.

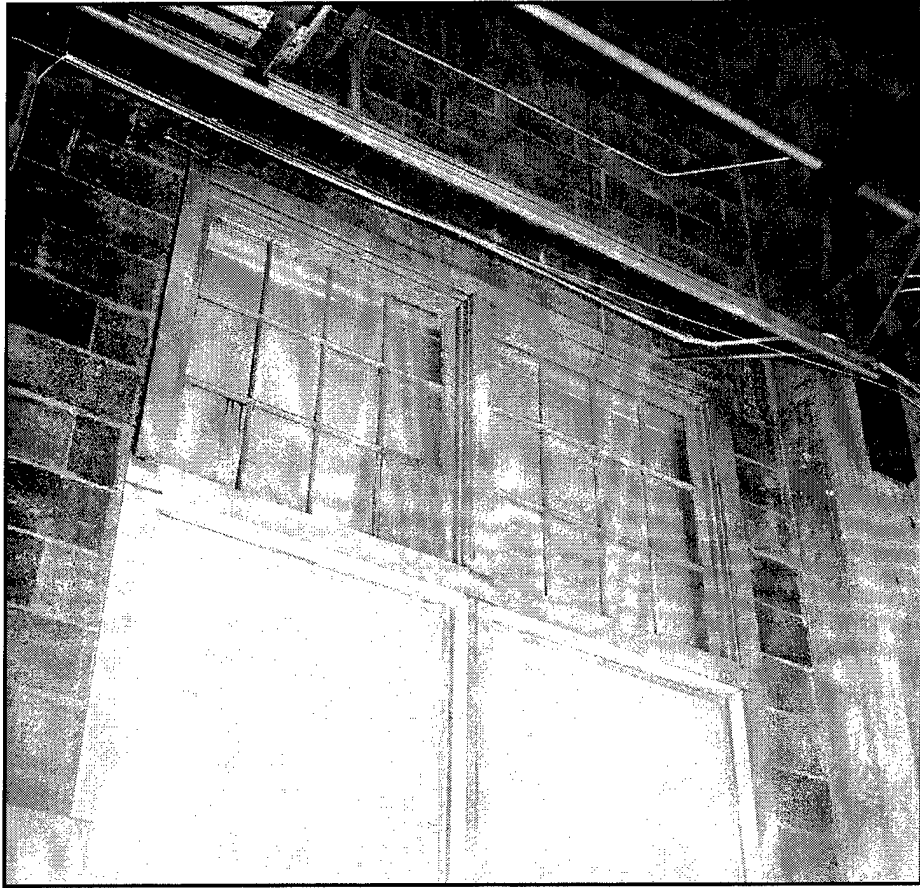
Figure V.284 5EP1778. Building S6290, Steam Plant, 800 Series, Types HSP-8, -9, -10, and -11. Interior shot of window fenestration detail. Roll 5F, Exposure 3.

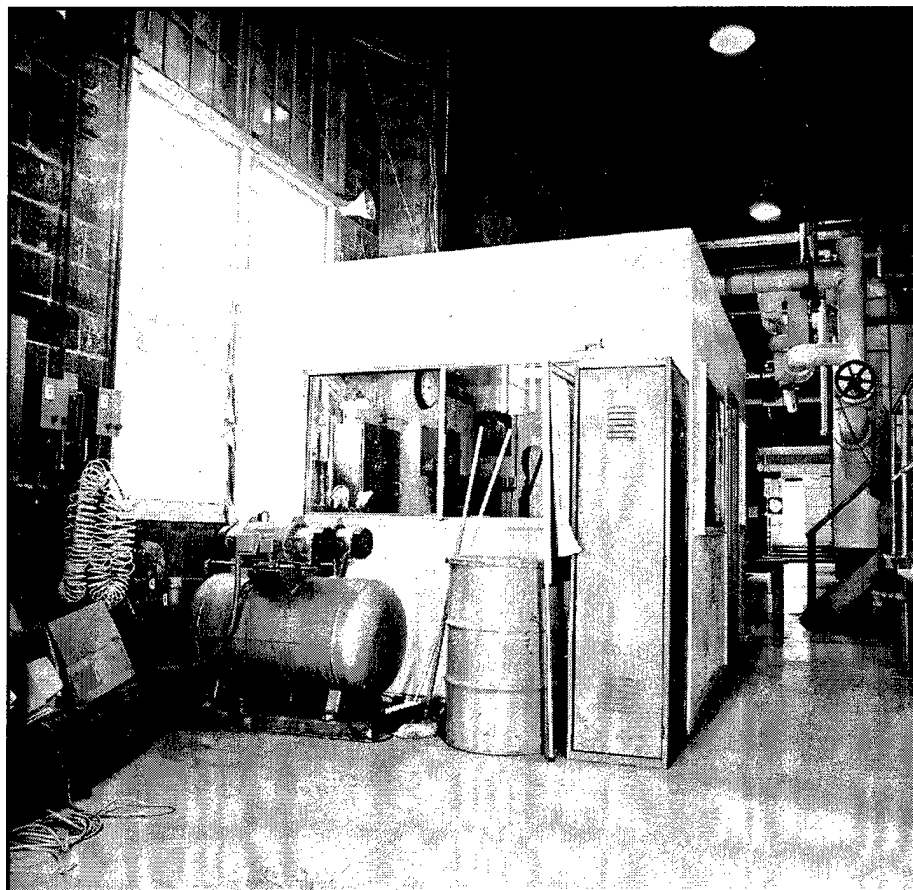
Figure V.285 5EP1778. Building S6290, Steam Plant, 800 Series, Types HSP-8, -9, -10, and -11. Interior shot of small office on building's south side, viewed facing west. Roll 4F, Exposure 9
